DOT/FAA/AM-05/18  
Office of Aerospace Medicine  
Washington, DC 20591

# Reliability of the Gas Supply in the Air Force Emergency Passenger Oxygen System

October 2005

Final Report

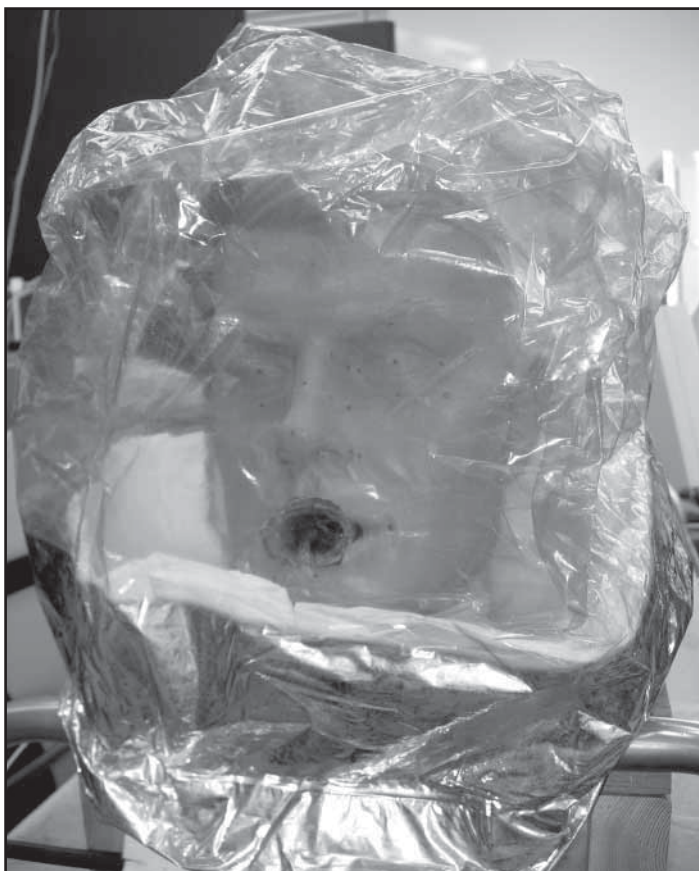
**Figure 1.** The Emergency Passenger Oxygen System evaluated in this study. The unit contains a single oxygen cylinder (not visible) that is normally opened to the interior of the unit when taken from the packaging for donning.

14. Sponsoring Agency Code	
15. Supplemental Notes					
16. Abstract <p>The protective breathing equipment (PBE) procured by the U.S. Air Force as Emergency Passenger Oxygen System (EPOS; Fig. 1) was alleged to have significant numbers of inadequate oxygen cylinders. In theory, this could prevent the PBE from providing the required time of protection for the user. The Civil Aerospace Medical Institute was requested to participate in the testing for the possibility of inadequate oxygen cylinders through the U.S. Air Force Office of Special Investigations. To test for any potential leakage and therefore an inadequate quantity of oxygen, EPOS units were collected from Air Force bases and submitted by the manufacturer for a series of tests. The primary indicator in the testing was the mass (weight) of oxygen in the cylinder. A total of 92 oxygen cylinders that were manufactured for assembly into EPOS or similar models of PBE were evaluated. Estimated dates of manufacture were between January 1989 and November of 2003. Four tests were conducted. The first measurement was the oxygen concentration in the vacuum-packaged PBE. The oxygen cylinders were then removed from the PBE and any difference between the current cylinder weight and the cylinder weight at manufacture was recorded. The cylinders were then exposed to 40,000 feet altitude in a hypobaric chamber for 4 hours. Weights before and after the chamber exposure were recorded. Finally, the cylinders were emptied of oxygen and the empty cylinder weight recorded. Two oxygen cylinders had large oxygen deficits (&gt;11 grams). Based on the results of the altitude testing, the loss did not appear to be related to diffusion out of the cylinder. Therefore, other explanations need to be examined as to why these two cylinder shortages existed.</p>
